Peconic Home Inspections, LLC  
[www.HomeInspectionPHI.com](http://www.HomeInspectionPHI.com)

# Inspection Report

123 Lane  
Suffolk, New York 11900

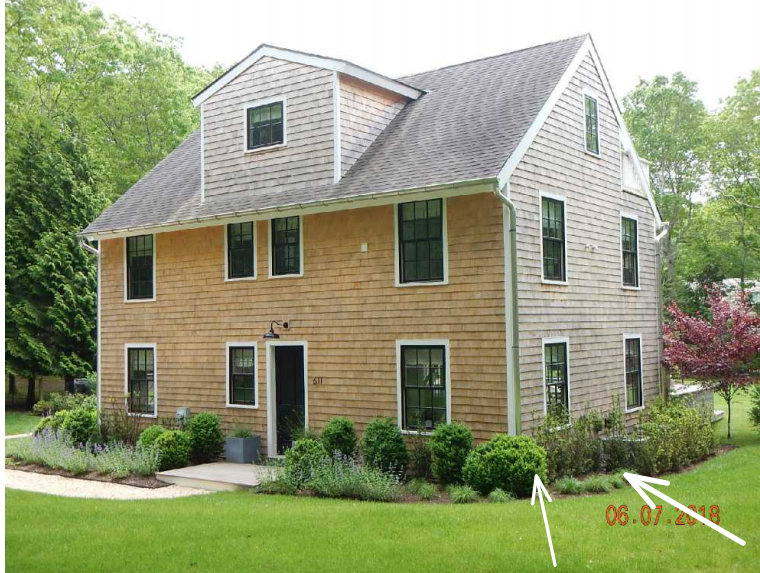
Maintenance Items Grading: Minor slope towards the front right corner of house. Improper soil slope towards foundation, recommend landscaping to divert moisture from running towards foundation.

1. Grading: Minor slope towards the front right corner of house. Improper soil slope towards foundation, recommend landscaping to divert moisture from running towards foundation.

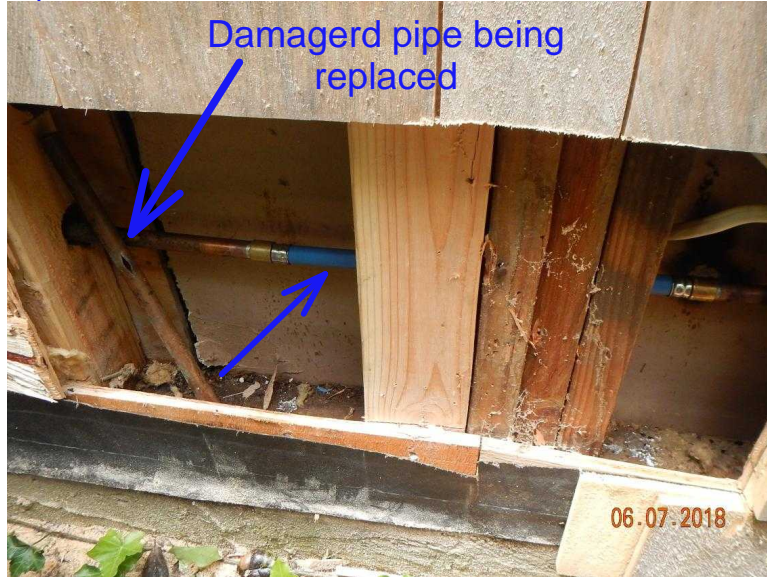
Outside Shower: Not functional at time of inspection. Due to damaged pipe replacement

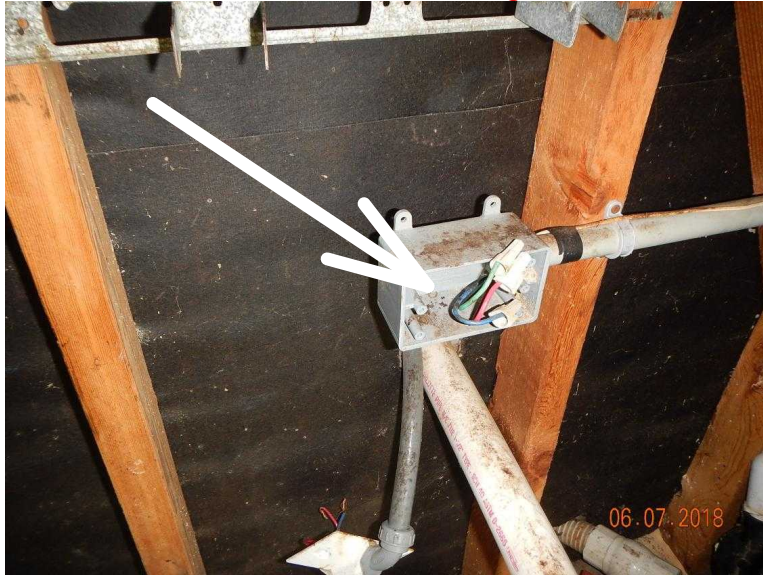
Electrical: 110 VAC - **Install missing outlet/switch cover plate**

1. Back yard. Pool Shed/storage. Outbuilding Electrical: 110 VAC - **Install missing outlet/switch cover plate**

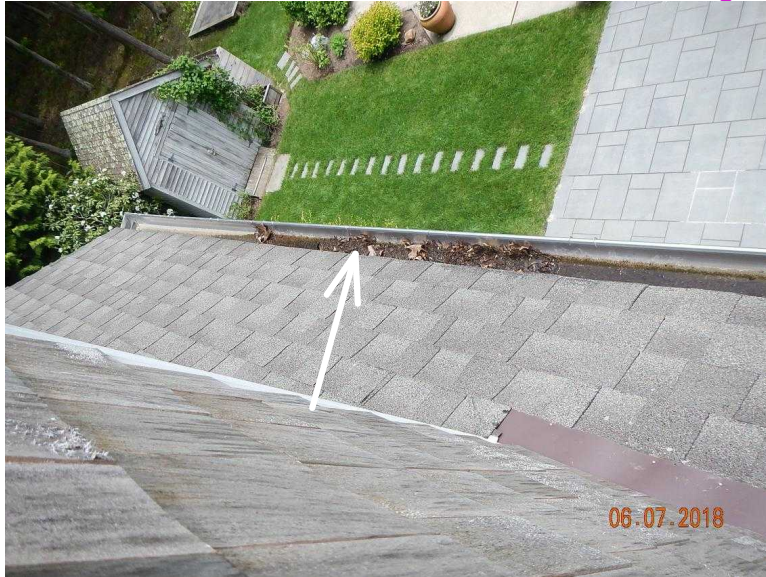
Maintenance Items Gutters: Metal. Gutters need to be kept cleaned to ensure proper water flow. This should eliminated ice dams and other water damage.

3. Gutters: Metal. Gutters need to be kept cleaned to ensure proper water flow. This should eliminated ice dams and other water damage.
4. Downspouts: Metal, some into drywells. Divert water away from foundation. Water causes problems with foundations.

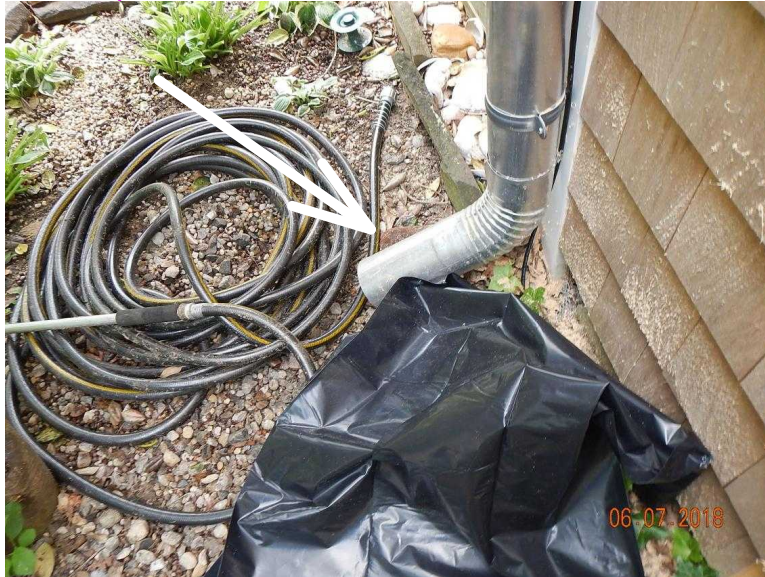
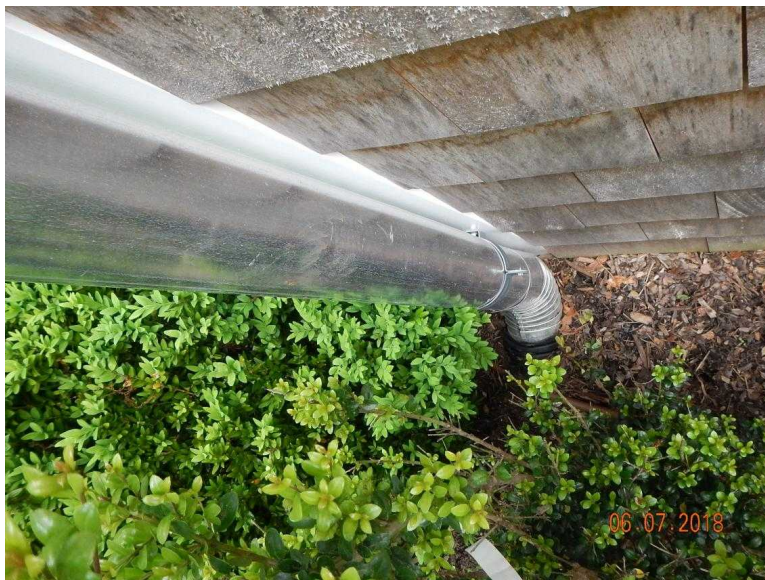
Maintenance Items Downspouts: Metal, some into drywells. **Divert water away from foundation. Water causes problems with foundations.**

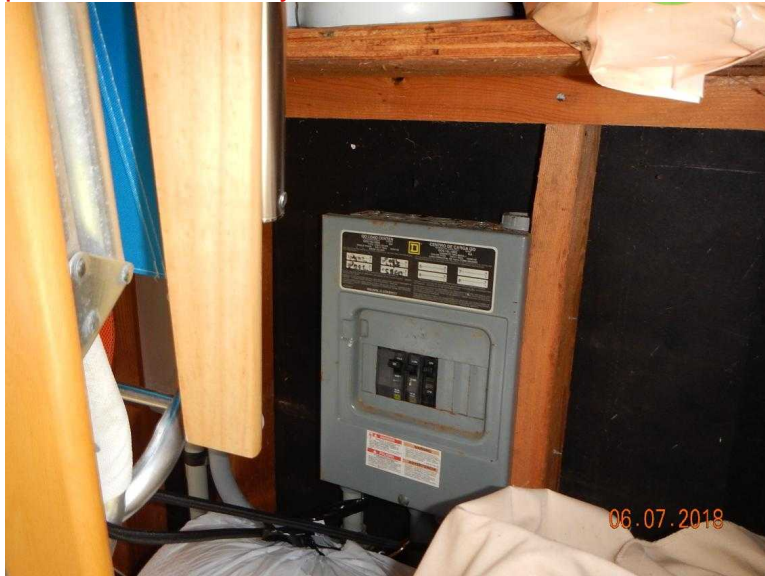
Manufacturer: Square D. Sub Panel - Ground and neutral are not isolated in sub panel. Evaluation by a licensed electrician is recommended

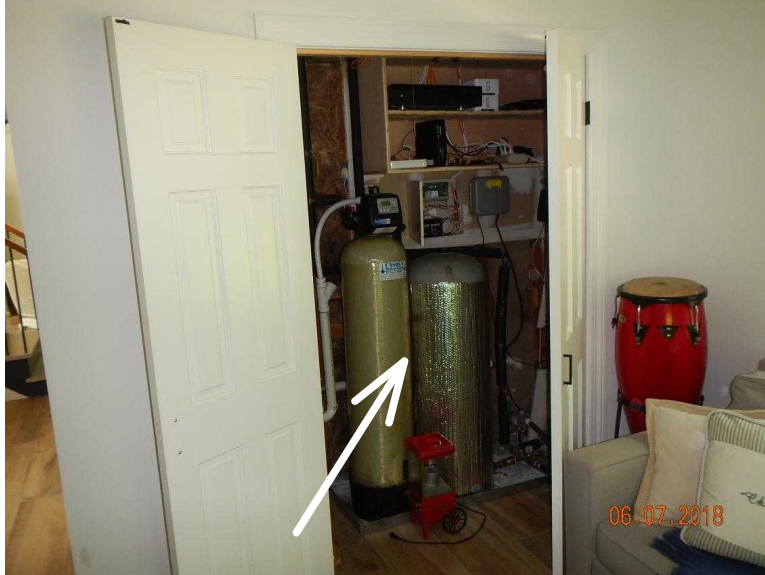
Water Filter Whole house conditioner. **Should be Serviced regularly. See manufactures recommendations. Ask Owner for paper work.**

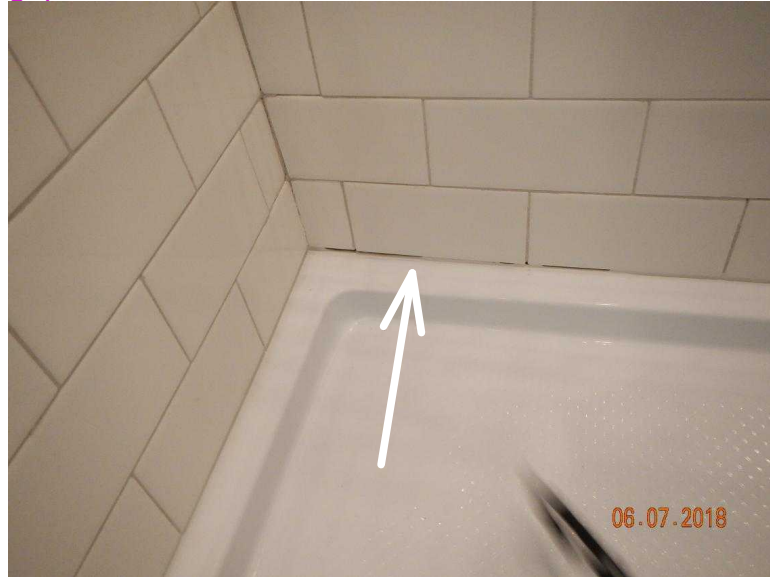
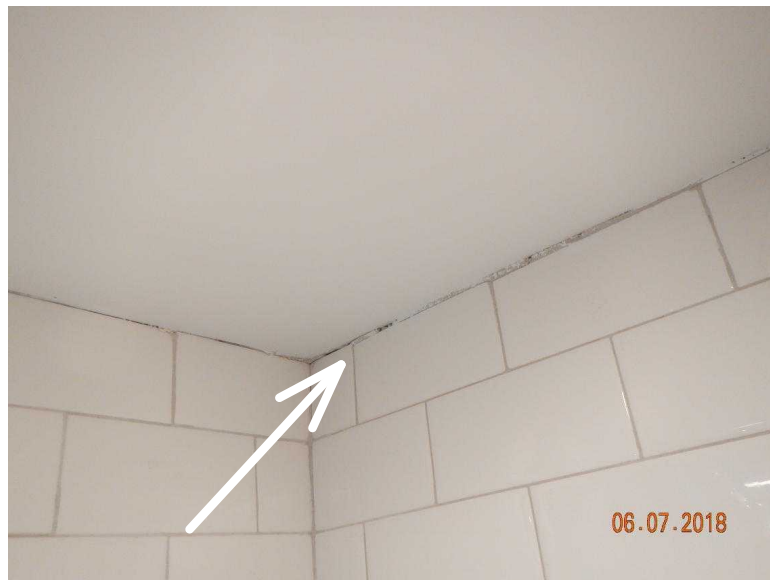
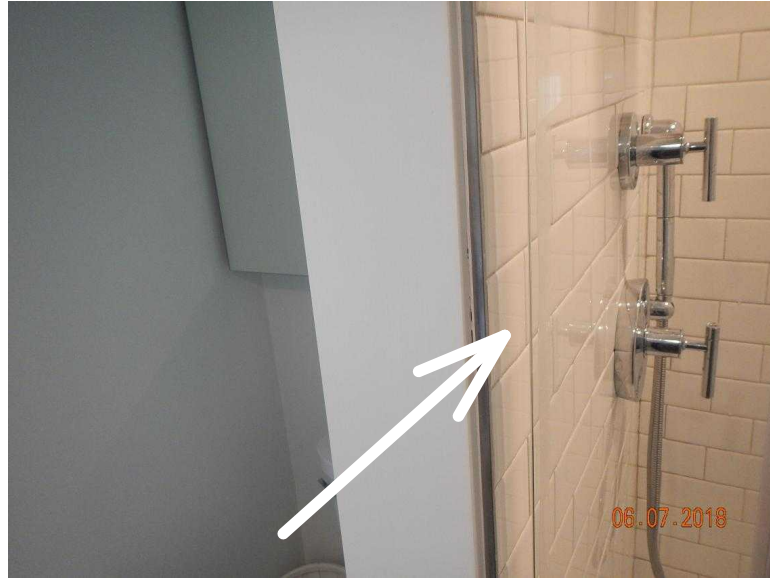
Acceptable, Maintenance Items Shower/Surround: Complete tile, with glass doors. Grout/caulking is required in some areas. Glass door does not line up with tile wall. Large gap.

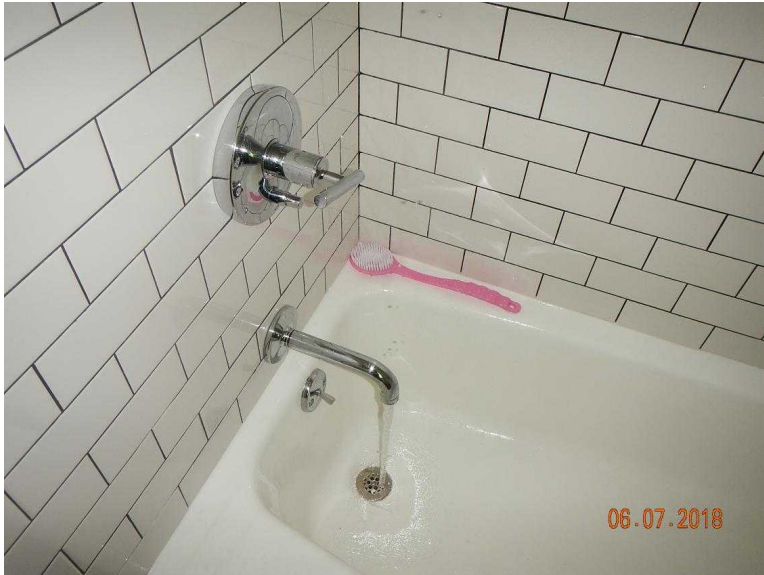
Ceiling: Paint on sheet rock.  
Walls: Paint on sheet rock.  
Floor: Painted wood.  
Doors: Wood.  
Windows: Vinyl double hung.  
Electrical: 110 VAC GFCI - **Faulty GFCI outlet-replace**  
Counter/Cabinet: No problems observed.  
Sink/Basin: Functional at the time of the inspection.  
Faucets/Traps: Functional at the time of the inspection.  
Shower/Tub/Surround: Functional at the time of the inspection.

4. 2nd floor - hallway. Bathroom Electrical: 110 VAC GFCI - **Faulty GFCI outlet-replace**
5. 1st floor. Half Bathroom Electrical: 110 VAC GFCI - **Faulty GFCI outlet-replace**

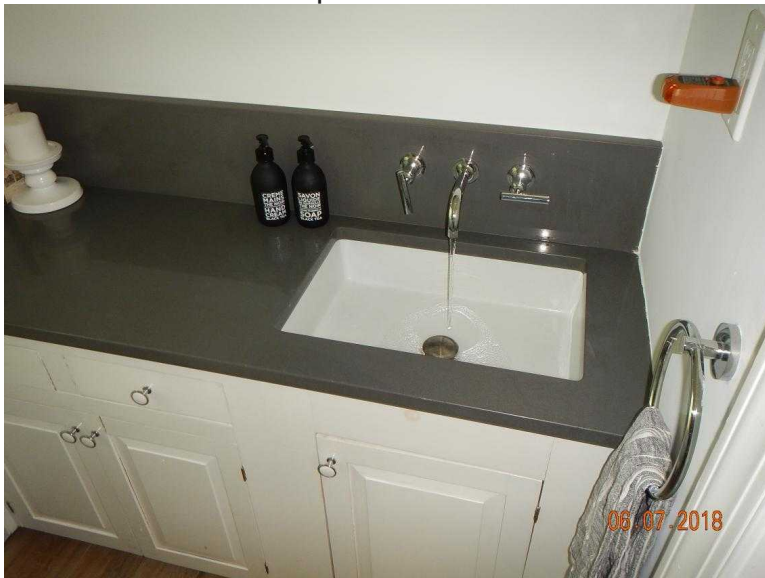
Electrical: 110 VAC GFCI - **Faulty GFCI outlet-replace**

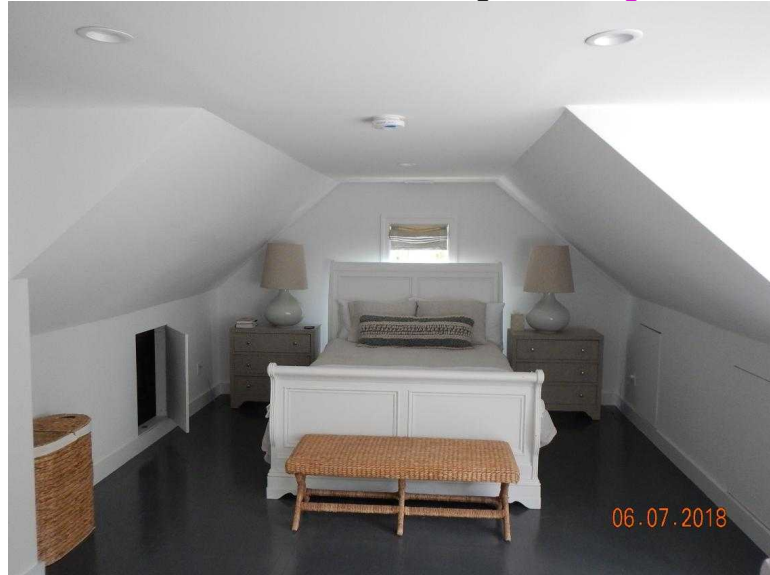
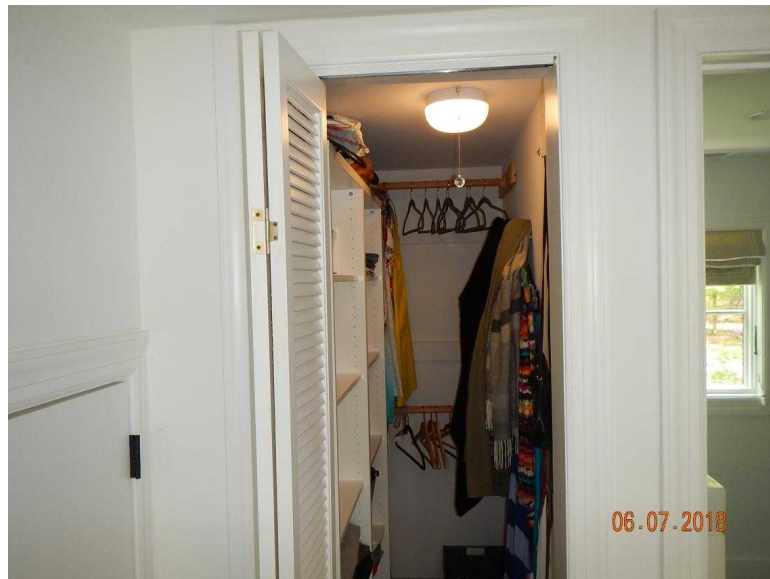
Acceptable, Maintenance Items Closet: Walk In., Knee wall storage. **Fix hinges on knee wall doors**

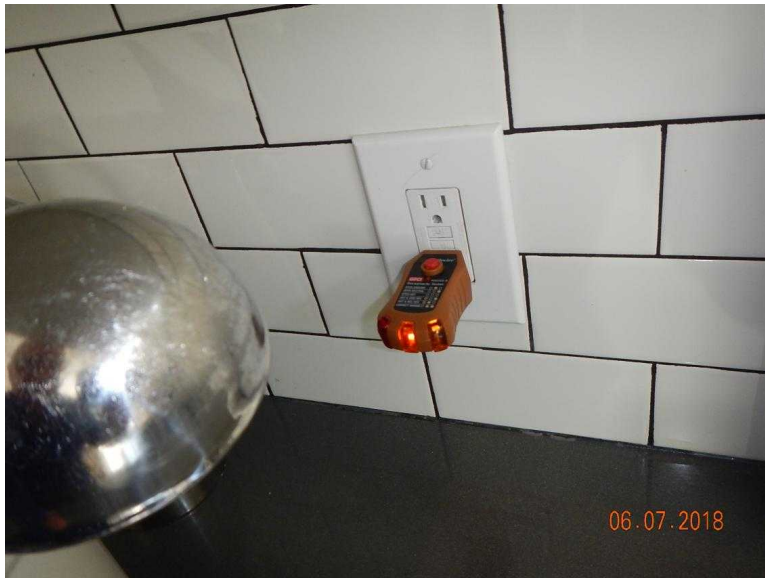
Electrical: 110 VAC GFCI Not functional at the time of the inspection. **A licensed electrician is recommended to evaluate.**

6. Rear of house. Kitchen Electrical: 110 VAC GFCI Not functional at the time of the inspection. **A licensed electrician is recommended to evaluate.**

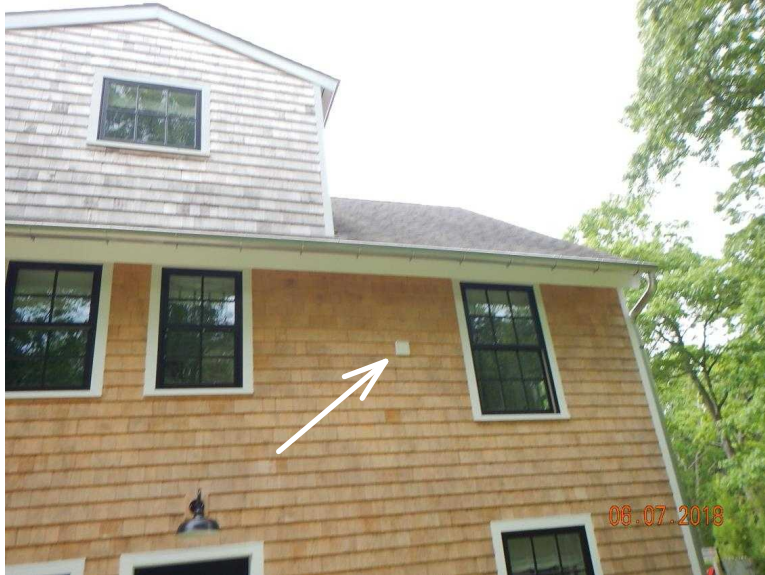
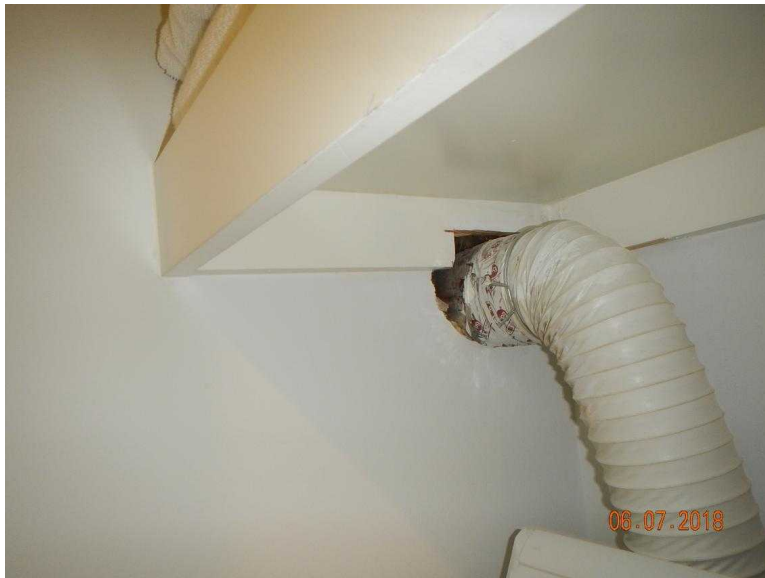
Dryer Vent: Plastic flex - **It is recommended that the flex venting be changed to a rigid piping. Fire/Safety issue.**

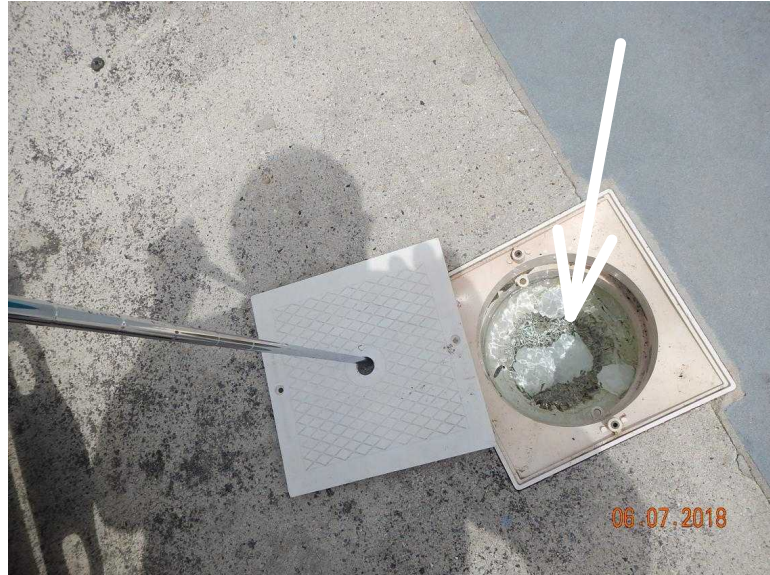
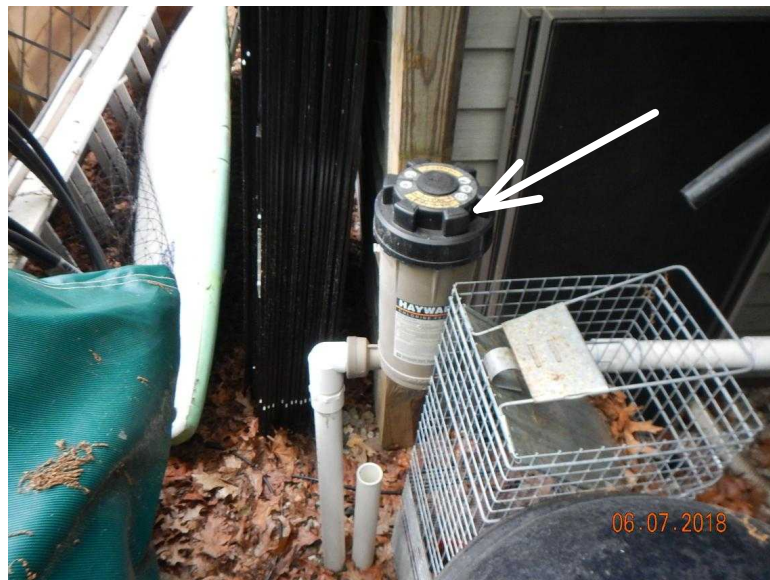
Acceptable, Maintenance Items Skimmer: Plastic, Functional at time of inspection. Chlorine tabs should be placed in auto chlorinator and not the return skimmers especially if there is a heater.

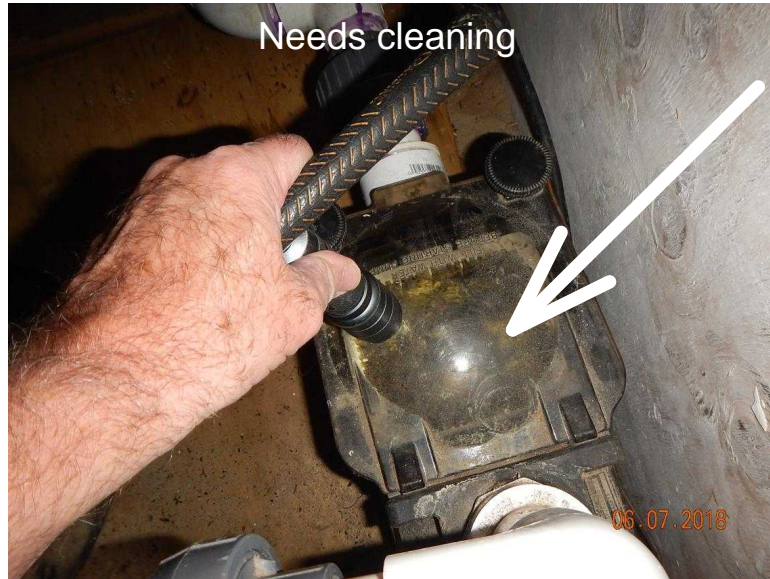
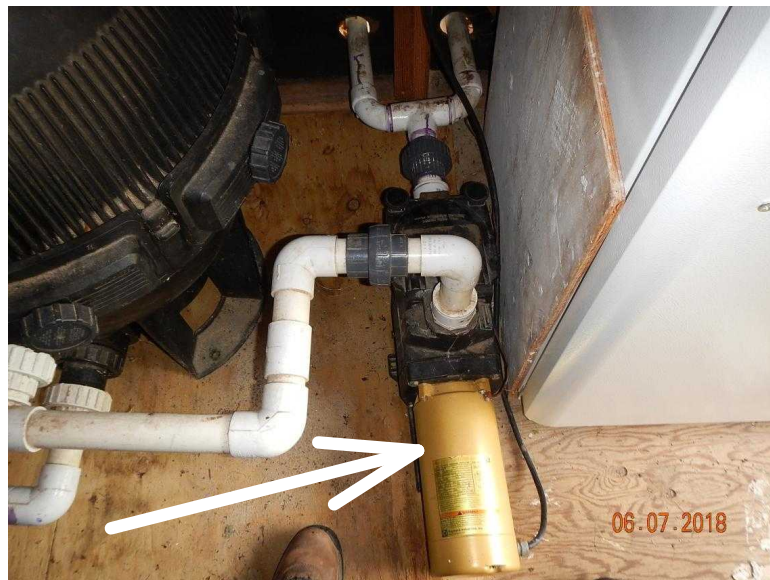
Acceptable, Maintenance Items Pump Motor: Functional at time of inspection. **Basket needs to be cleaned**

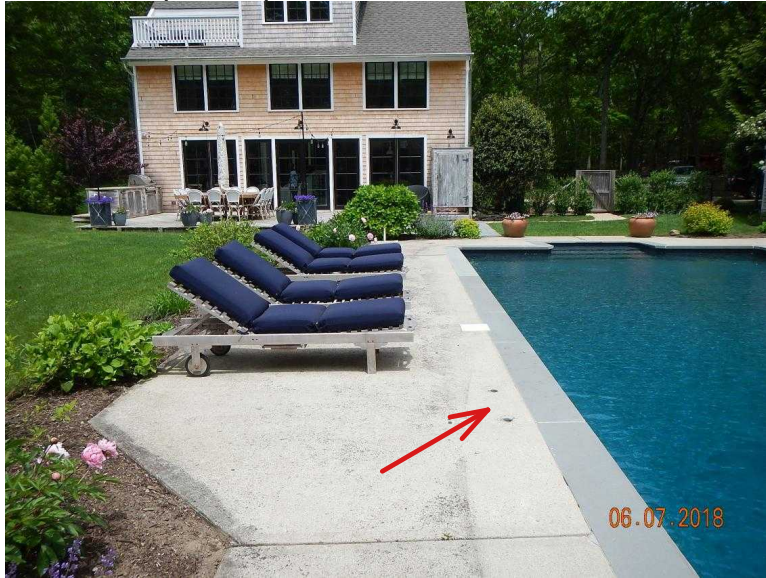
Acceptable, Safety Ladder/Steps: Steps no ladders. **Ladder not installed. Safety issues for deep end**
